# **A DATA-DRIVEN CONDITION ASSESSMENT**

FOR ASPHALT REJUVENATION USING  
MALTENE REPLACEMENT  
TECHNOLOGY

SEPTEMBER 2021  
PREPARED BY JAMES GOLDEN

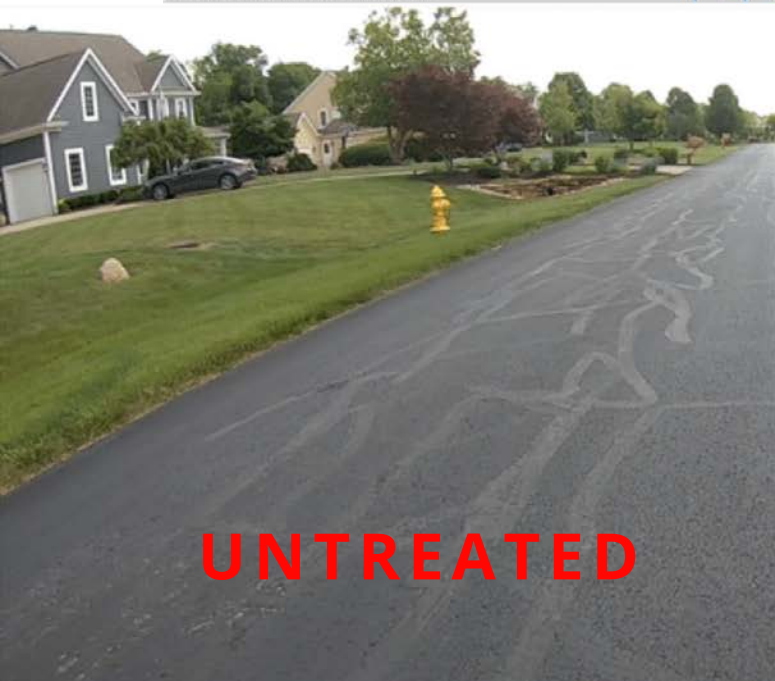
## UNTREATED

The untreated lane shows noticeable longitudinal and transverse cracking that has been treated with a crack seal since being paved in 2013. Furthermore, you can see signs of raveling throughout 10% of the surface, and weathering throughout 100% of the surface.

After documenting these distresses within the PAVER® pavement management system, the PCI of the untreated lane is a 70.

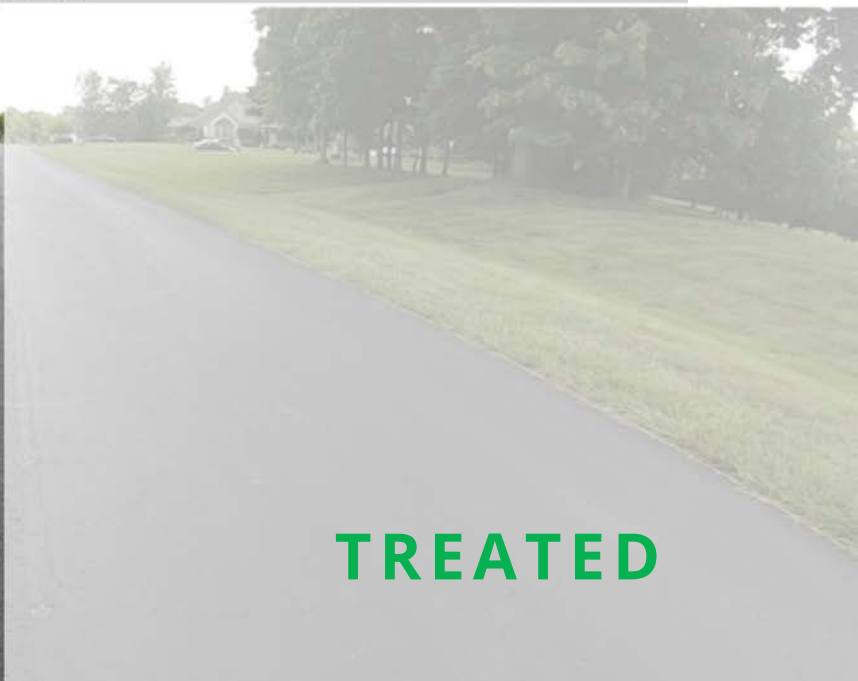
## TREATED

The treated lane shows that while longitudinal and transverse cracking is visible, it has just started to form and take shape. Furthermore, there are no signs of raveling within the treated surface, with light severity weathering only present within 20% of the surface.

After documenting these distresses within the PAVER® pavement management system, the PCI of the treated lane is 84.

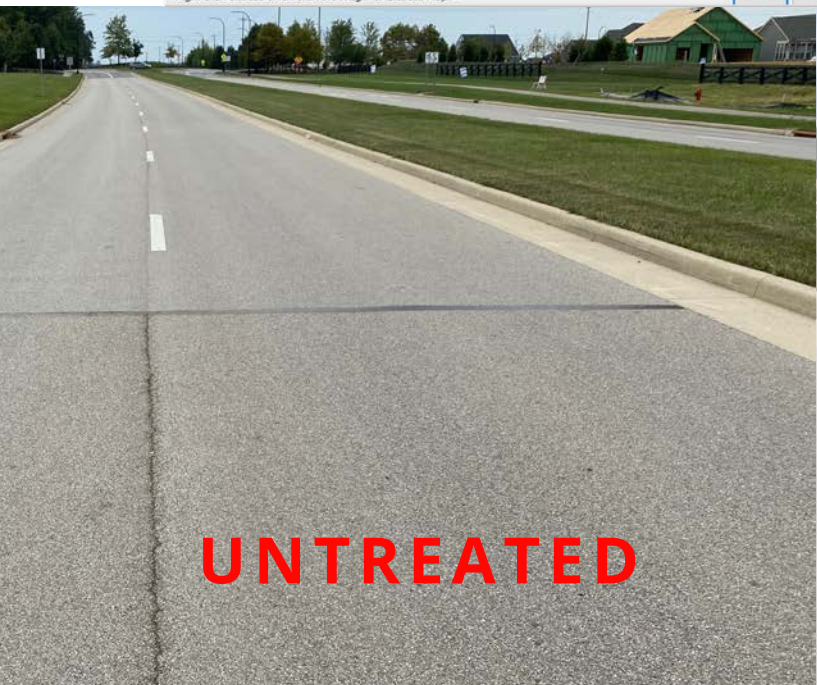
## UNTREATED

The untreated segment shows noticeable light and medium severity longitudinal cracking along the paving joint with light severity weathering present throughout 100% of the surface.

After documenting these distresses within the PAVER® pavement management system, the PCI of the untreated segment is 85.

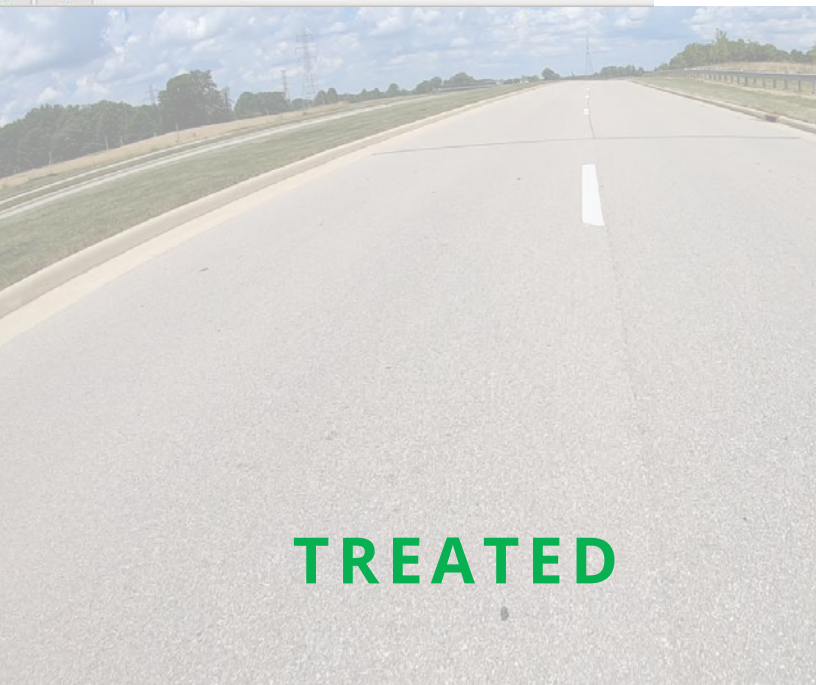
## TREATED

The treated segment shows minimal, light severity longitudinal cracking along the paving joint, with light severity weathering present throughout just 50% of the surface.

After documenting these distresses within the PAVER® pavement management system, the PCI of the treated segment is 95.

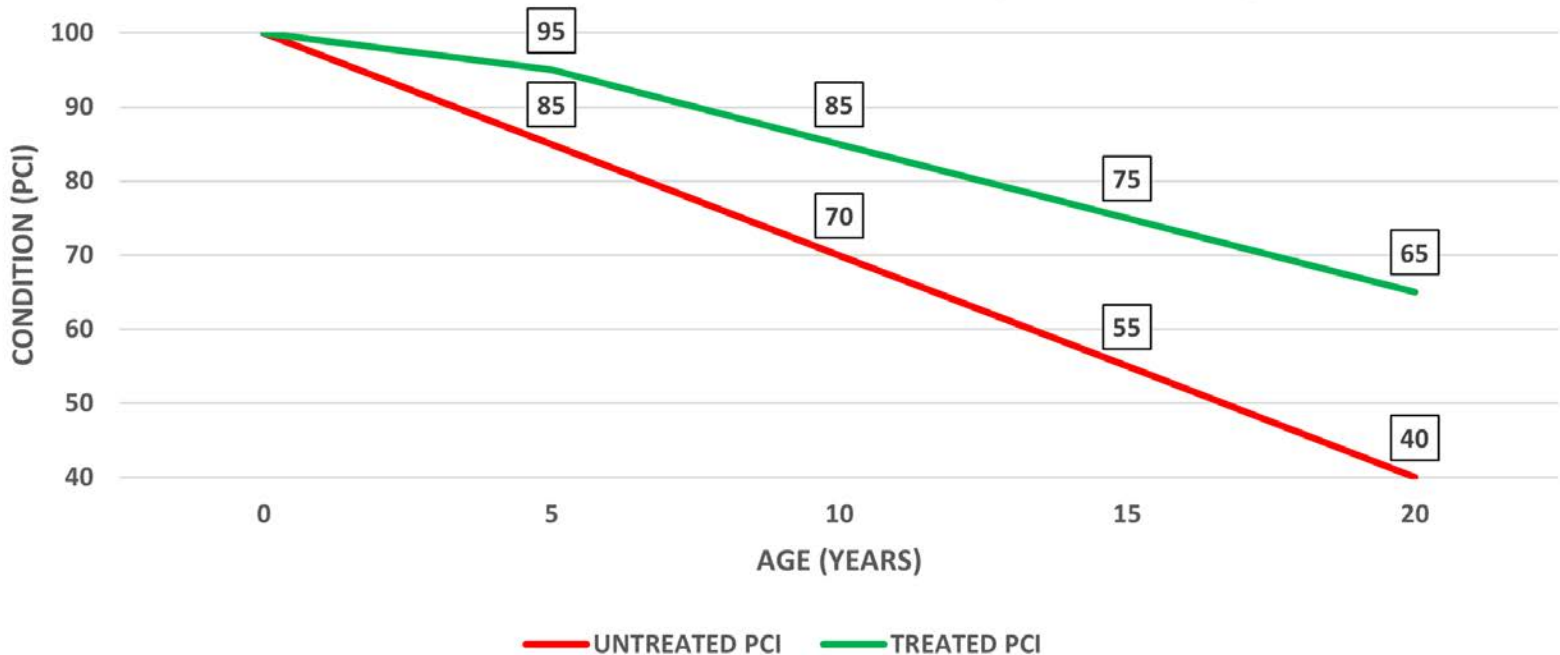
## PAVEMENT LIFECYCLE UNTREATED VS TREATED

Based upon the age of each pavement and PCI calculated from the ASTM D6433 condition assessment, the untreated locations lost an average of 3.5 PCI points per year, while the treated locations lost an average of just 1.5 points per year; resulting in a 2 point PCI gain.

It is within my professional opinion that an MRT application within the first three (3) years of an asphalt pavement's life will extend the life by up to an additional five (5) years, as shown in the below performance curves created directly from the aggregated data documented within this report.
