GAINESVILLE REGIONAL AIRPORT

RUNWAY 7/25 PAVEMENT PRESERVATION

*Maltene-Based Rejuvenation: Five-Year Performance Evaluation,
Binder Rheology Analysis & Life Cycle Cost Assessment*

Prepared For:	Gainesville Regional Airport Authority / FDOT State Materials Office
Subject Runway:	GNV Runway 7/25 — Alachua County, Florida
Evaluation Date:	August 17, 2021 (5-Year Monitoring Survey)
Author / Discipline:	Pavement Technologist — Binder Rheology & Preservation Chemistry (Ph.D., Civil Engineering)
Report Date:	March 2026

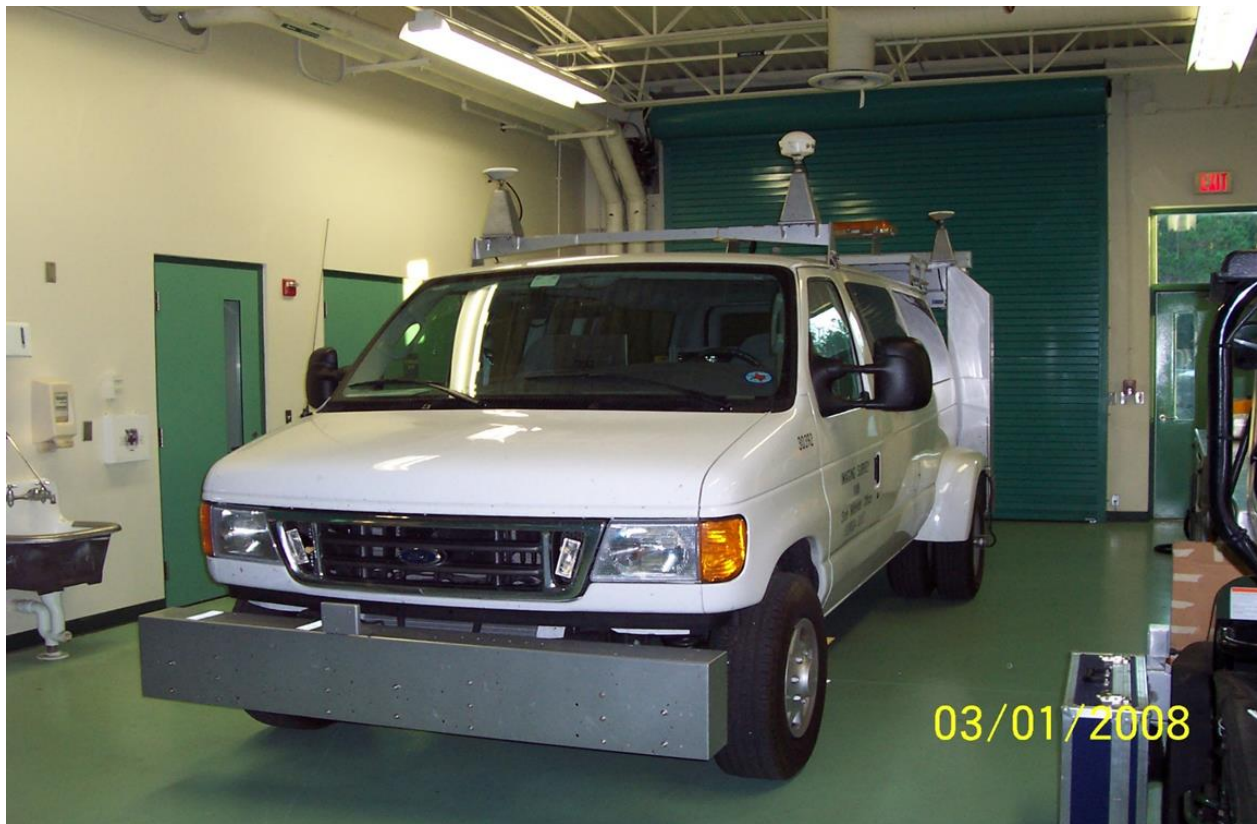
FIGURE 3-1: Photo of FDOT Multi-Purpose Survey Vehicle (MPSV)

Annual pavement imaging was performed using the FDOT Multi-Purpose Survey Vehicle (MPSV), which captures high-resolution digital imagery of the pavement surface to document crack development. In 2018, only approximately 15 linear feet of total low-severity cracking was observed across the entire runway, indicating that all sections were performing well at the three-year mark. The 2021 survey detected a significantly higher total crack inventory, reflective of the accelerated aging typical of pavement binders in the Florida climate between years 3 and 5 post-construction. [GNV 2021 Evaluation Memo, p. 7]

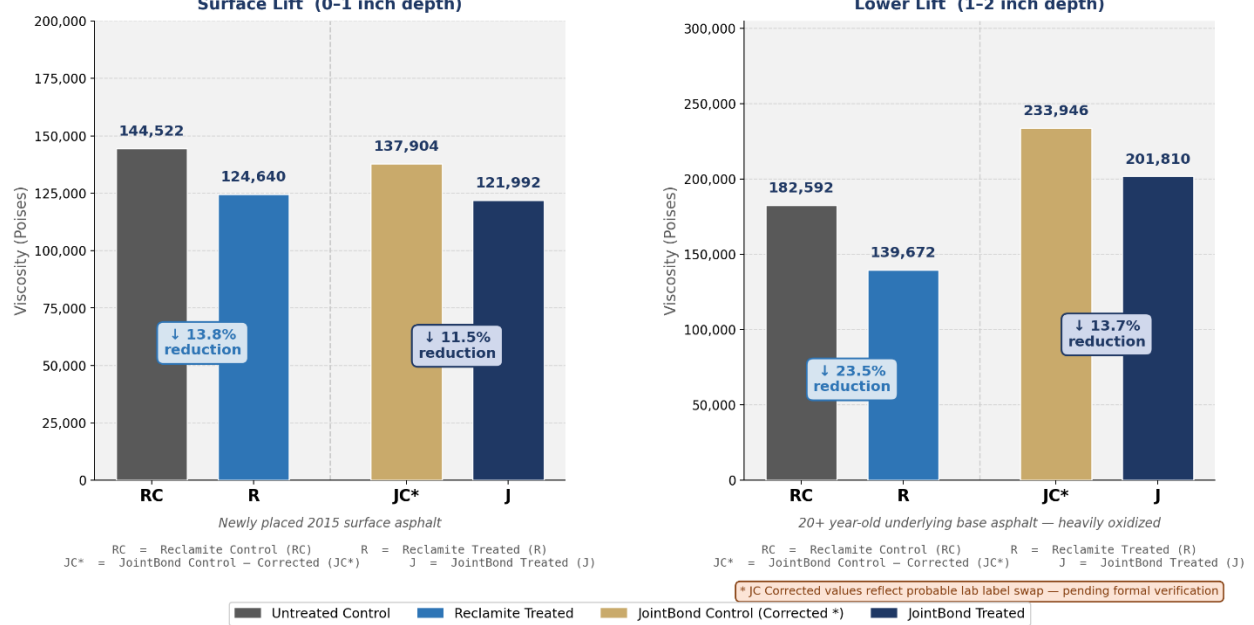
FIGURE 4-1: Core Viscosity Comparison

When the corrected JC data is applied, the full core extraction dataset tells a coherent and encouraging story. Both Reclamite and JointBond performed exactly as designed across two distinct asphalt layers with very different aging profiles. At the surface (0–1 inch), both products reduced viscosity by 11–14% and lowered the high-temperature grade by 2–4°C — confirming effective binder restoration in the recently placed surface lift. At depth (1–2 inch), both products penetrated into a severely aged underlying base layer and achieved measurable softening despite the exceptionally high starting viscosity of that layer — with nearly identical temperature grade reductions of approximately 1.7–1.8°C for both products. [GNV Rejuvenator Cores Lab Report]

Figure 4-1: Core Extraction Viscosity — Treated vs. Control, Surface & Lower Lift
 GNV Runway 7/25 | High Temp. Grade Viscosity (Poises) | [GNV Rejuvenator Cores Lab Report, Corrected]

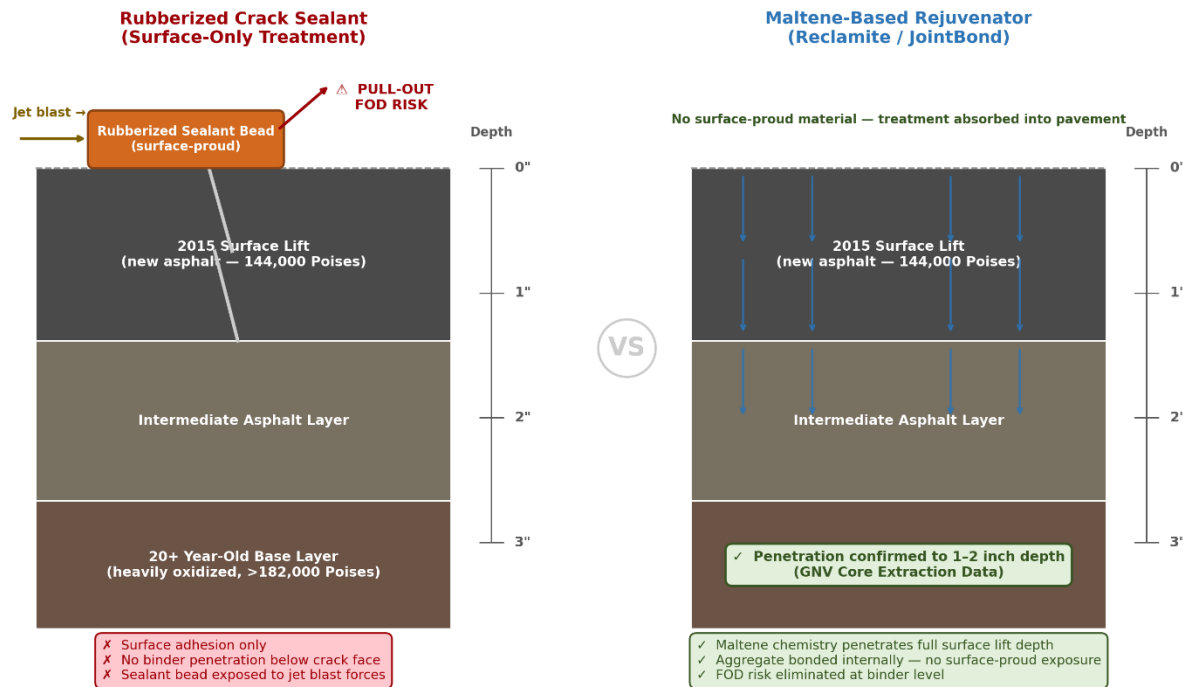
FIGURE 5-1: FOD Risk Schematic

- Penetration Depth: Maltene rejuvenator — up to 1–2 inches (confirmed GNV core data); Rubberized sealant — surface only (0–0.25 in.)
- Aggregate Bonding Mechanism: Maltene — internal binder matrix restoration; Rubberized sealant — surface adhesion to oxidized aggregate face
- Pull-Out Risk: Maltene — minimal (aggregate retained by restored binder matrix); Rubberized sealant — high (debonding at oxidized interface common under thermal cycling)
- FOD Generation Potential: Maltene — low; Rubberized sealant — moderate to high in aged pavement, especially at joint edges
- Jet Blast Resistance: Maltene — high (no surface-proud material); Rubberized sealant — moderate (proud bead subject to shear under blast velocity)
- FAA Advisory: AC 150/5370-10 recommends crack sealing but notes that pull-out of sealant material must be minimized — maltene chemistry eliminates this risk category entirely

Figure 5-1: FOD Risk Schematic — Surface-Only Sealant vs. Maltene Deep Penetration
GNV Runway 7/25 Pavement Preservation Study

Traditional rubberized crack sealants and surface seals operate exclusively at the surface of the pavement — they fill void spaces and seal cracks from above, but do not penetrate the binder matrix at depth. As a consequence, these products are subject to 'pull-out' failure modes in which the sealant itself debonds from the crack face under thermal cycling or wheel loading, potentially generating debris. The adhesion of a surface-applied sealant is only as strong as its bond to the oxidized aggregate-binder interface it is applied to.

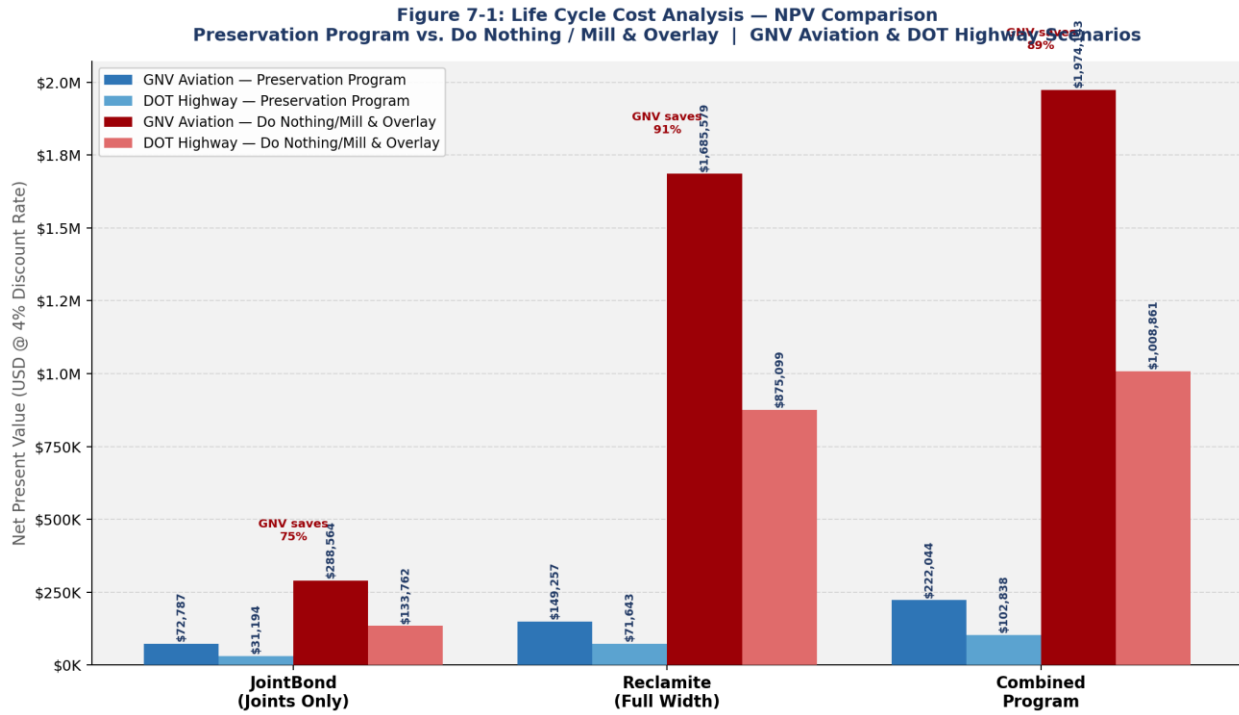
FIGURE 7-1: NPV Comparison

- GNV Aviation: The full JointBond + Reclamite preservation program costs \$222,044 NPV vs. \$1,974,143 for Do Nothing — an 88.8% saving of \$1,752,099 per runway mile
- DOT Highway: The program costs \$102,838 NPV vs. \$1,008,861 for Do Nothing — saving \$906,023 per lane-mile per direction (89.8%)
- The combined preservation cost annualizes to approximately \$0.29/SY/year over the treatment window (GNV scenario) — the lowest cost-per-year of any strategy evaluated
- Every \$1.00 invested in the combined preservation program avoids approximately \$8.88 in future Do Nothing rehabilitation cost (GNV aviation scenario)
- The preservation program requires only 4 total treatment events (2 JointBond + 2 Reclamite base) over the evaluation window vs. 1 catastrophic full-width mill and overlay event under Do Nothing — the preservation path is both cheaper and operationally less disruptive

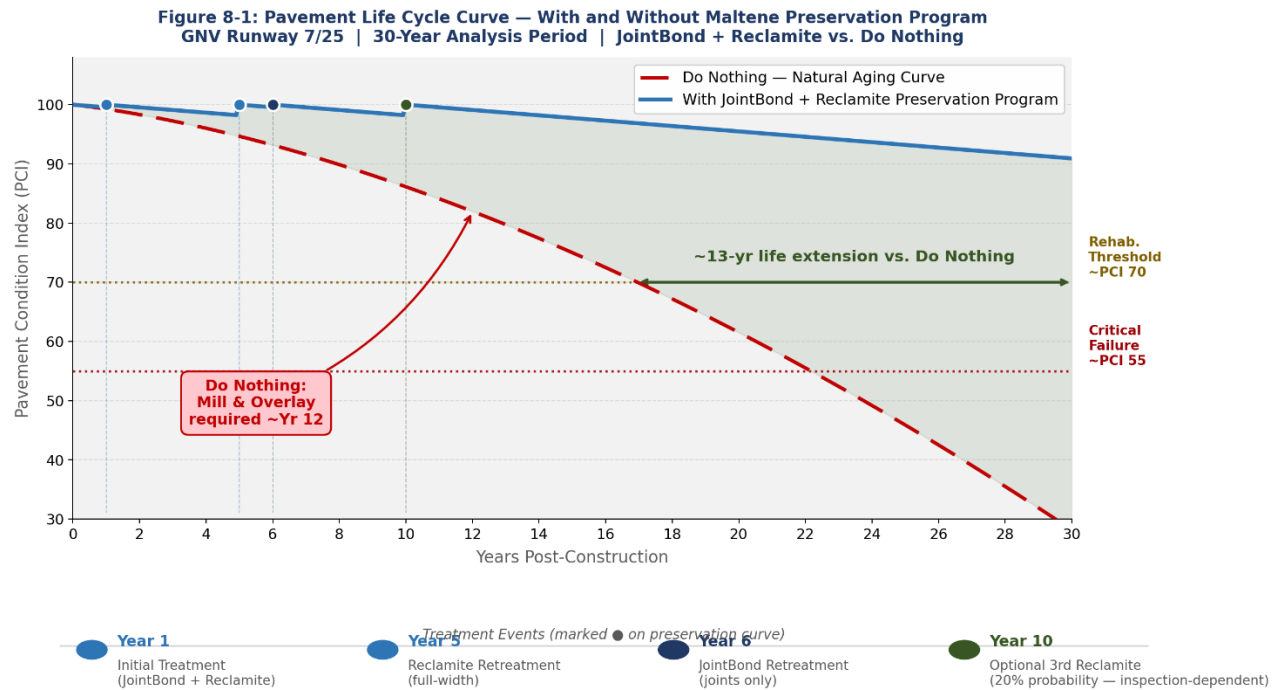
FIGURE 8-1: Pavement Life Cycle Timeline

The following schedule is structured around two primary treatment events: an Initial Treatment targeting binder restoration before significant oxidative brittleness develops, and a Secondary Extension at Year 6 to sustain the restored binder condition through the mid-life of the pavement. Subsequent treatments follow on a 6-year cycle contingent on condition monitoring results.

Year	Treatment Event	Scope of Work	Performance Trigger	Expected Outcome
Year 1	Initial Treatment	Full runway / pavement surface application of maltene rejuvenator (Reclamite / JointBond) at design application rate	Proactive — applied within 1–2 years of new overlay placement, before Mu decline or cracking initiates	38%+ viscosity reduction (per CDOT spec.); G' reduction >40%; 3–5 year life extension initiated
Year 3	Condition Monitoring	Annual RFT friction survey; MPSV crack imaging; spot DFT if Mu trend indicates decline	Routine annual FAA compliance monitoring	Confirm Mu > 0.82; document crack inventory baseline for Year 6 planning
Year 6	Secondary Extension Treatment	Second maltene rejuvenator application; crack sealing of any low-severity longitudinal cracks with JointBond product; re-survey post-treatment	Mu approaching 0.85 threshold on trend; DFT40 below 0.65; any crack area >0.5%	Sustained binder viscosity; crack propagation arrested; additional 3–5 year life extension; continued FOD risk suppression
