# **A DATA-DRIVEN CONDITION ASSESSMENT**

FOR ASPHALT REJUVENATION USING  
MALTENE REPLACEMENT  
TECHNOLOGY

SEPTEMBER 2021  
PREPARED BY JAMES GOLDEN

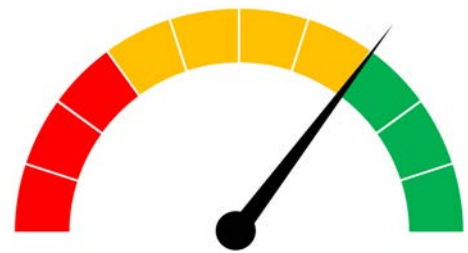
### 70 PCI

## STREAMSIDE DRIVE, **UNTREATED**

The untreated lane shows noticeable longitudinal and transverse cracking that has been treated with a crack seal since being paved in 2013. Furthermore, you can see signs of raveling throughout 10% of the surface, and weathering throughout 100% of the surface.

After documenting these distresses within the PAVER® pavement management system, the PCI of the untreated lane is a 70.

| Distress | Description | Severity | Quantity | Units | Density | Deduct |
|---|---|---|---|---|---|---|
| 10 | L & T CR | Low | 300.00 | R | 15.00 | 20.72 |
| 19 | RAVELING | Medium | 200.00 | SqFt | 10.00 | 18.48 |
| 20 | WEATHERING | Low | 2,000.00 | SqFt | 100.00 | 5.18 |

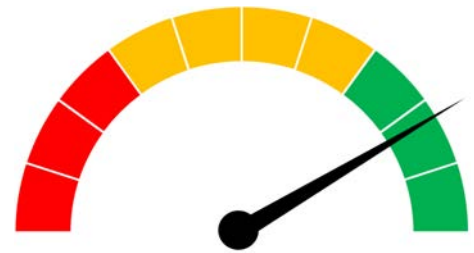
### 84 PCI

## STREAMSIDE DRIVE, TREATED

The treated lane shows that while longitudinal and transverse cracking is visible, it has just started to form and take shape. Furthermore, there are no signs of raveling within the treated surface, with light severity weathering only present within 20% of the surface.

After documenting these distresses within the PAVER® pavement management system, the PCI of the treated lane is 84.

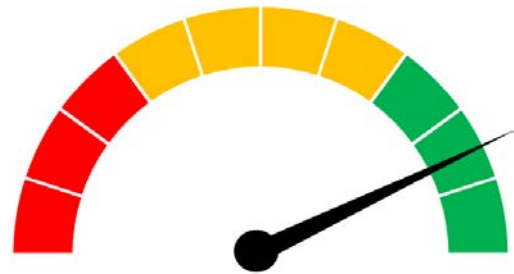
### 85 PCI

## SAWMILL PARKWAY, **UNTREATED**

The untreated segment shows noticeable light and medium severity longitudinal cracking along the paving joint with light severity weathering present throughout 100% of the surface.

After documenting these distresses within the PAVER® pavement management system, the PCI of the untreated segment is 85.

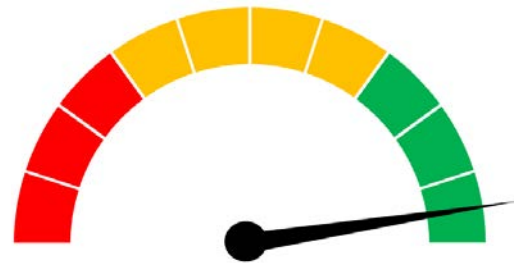
### 95 PCI

The treated segment shows minimal, light severity longitudinal cracking along the paving joint, with light severity weathering present throughout just 50% of the surface.

After documenting these distresses within the PAVER® pavement management system, the PCI of the treated segment is 95.
